[Docket No. 98-SW-74-AD; Amendment 39-11807; AD 2000-13-08]

#### Airworthiness Directives; Eurocopter Deutschland GmbH Model EC 135 Helicopters

**ACTION:** Final rule.

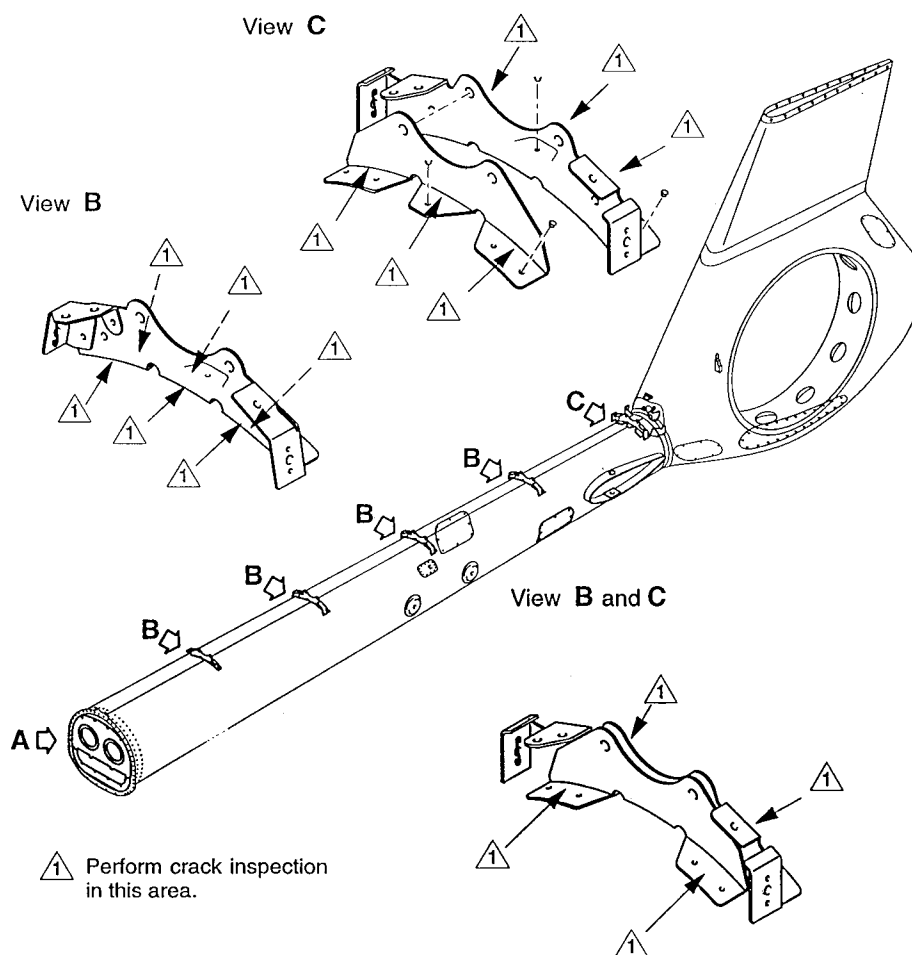
Figure 1

revising the required compliance time for the repetitive inspections of the bearing attach hardware and supports, and removing the requirement to contact the FAA if a lock plate tab is bent open or if slippage marks are broken or missing. This amendment is prompted by continued reports of misaligned or cracked bearing supports and loose bearing attachment bolts. The actions specified by this AD are intended to prevent loss of drive to the tail rotor and subsequent loss of control of the helicopter.

(1) Clean each tail rotor drive shaft bearing support. Using a 6-power or higher magnifying glass and a bright light, visually inspect the attach lugs of the bearing supports B and C (shown in Figure 1) for cracks, particularly in the area extending from the bend radius to the attaching screws and rivets connecting the bearing supports to the tail boom. Before further flight, replace each cracked bearing support with an airworthy bearing support.

(2) Inspect each bearing attach hardware lock plate for bent-open tabs and slippage marks for attach hardware looseness or rotation. Before further flight, replace any loose bearing attach hardware (including lock plates found bent or open due to bolt rotation) with airworthy hardware.
