DEPARTMENT OF TRANSPORTATION

Denial of Motor Vehicle Defect Petition, DP00-001

Appendix—Petition Analysis—DP00-001

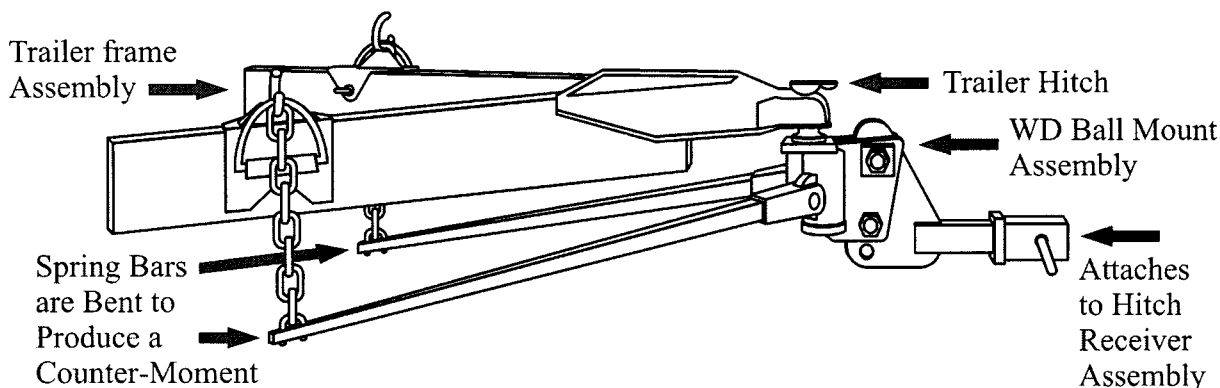
Figure 2. Typical Weight Distributing Hitch System Setup

shown in the set up of Figure 2, the two spring bars are bent upward to apply a counter moment torque to the WD hitch ball mount assembly and redirect or redistribute the point load tongue weight further forward in the tow vehicle. The subject vehicles' hitch receiver has a decal specifying 10,000 lb. towing and 1,000 lb. maximum tongue weight limits when used with the WD hitch system.

the loads to the entire tow vehicle. The WD hitch system's spring bars force both the front and rear wheel fenders equally downward. This aligns the tow vehicle so that it is approximately the same 'attitude' or 'level' as it was before the trailer was hooked up. A poorly installed WD hitch system can cause the tow vehicle's front end to 'lift up' resulting in more weight to the hitch receiver and rear axle. In addition, the ball mount height, spring bar angles, spring bar engagement level, and ball mount receiver bar length can also affect the proper installation and effectiveness of the WD hitch system.
