[Docket No. FAA-2013-0822; Directorate Identifier 2013-SW-004-AD; Amendment 39-17783; AD 2014-05-10]

#### **Airworthiness Directives; Airbus Helicopters (Type Certificate Previously Held by Eurocopter France) (Airbus Helicopters)**

**2014–05–10 Airbus Helicopters (Type Certificate Previously Held By Eurocopter France):** Amendment 39–17783; Docket No. FAA–2013–0822; Directorate Identifier 2013–SW–004–AD.

This AD defines the unsafe condition as severe vibrations due to failure of laminated half-bearings (bearings). This condition could result in failure of the tail rotor and subsequent loss of control of the helicopter.

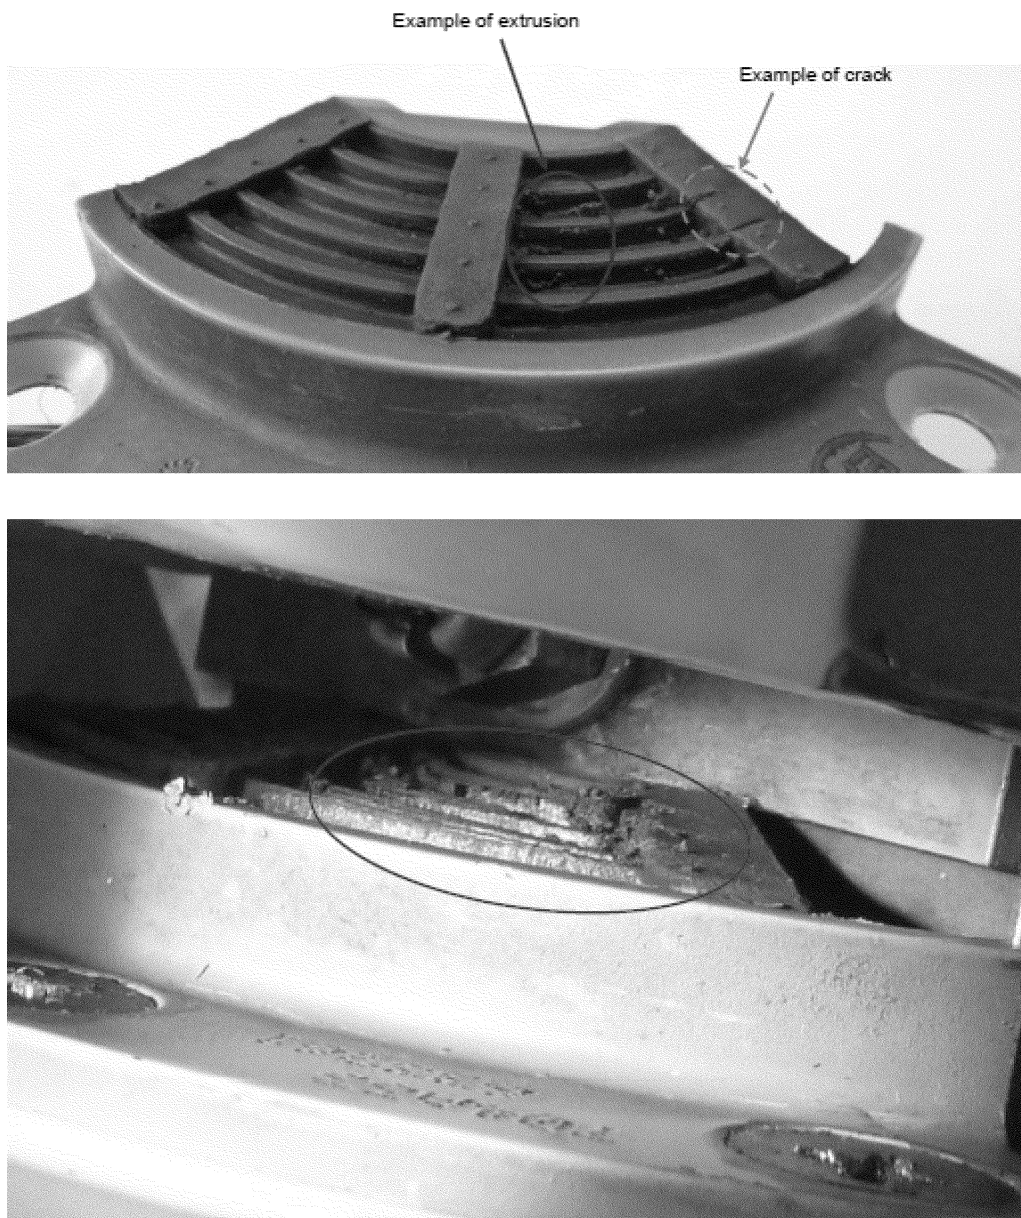
(C) While maintaining the load, check all the visible faces of the bearings (front and side faces) in area B of DETAIL A of Figure 3 to paragraph (f) of this AD for separation between the elastomer and metal parts, a crack in the elastomer, or an extrusion (see example in Figure 4 to paragraph (f) of this AD). A flashlight may be used to enhance the check.

(v) If there is an extrusion on any bearing, before further flight, replace the four bearings with airworthy bearings.

(vi) If there is a separation or a crack on the pressure side bearing, measure the separation or the crack. If the separation or crack is greater than 5 millimeters (.196 inches) as indicated by dimension “L” in Figure 6 to paragraph (f) of this AD, before further flight, replace the four bearings with airworthy bearings.
