Special Conditions: Aviation Technology Group, Inc., Javelin Model 100; High Altitude Operations

ACTION: Notice of proposed special conditions.

SUMMARY: This action proposes special conditions for the Aviation Technology Group, Inc., Javelin Model 100 airplane. This airplane will have a novel or unusual design feature(s) associated with high altitude operations. The applicable airworthiness regulations do not contain adequate or appropriate safety standards for these design features. These proposed special conditions contain the additional safety standards that the Administrator considers necessary to establish a level of safety equivalent to that established by the existing airworthiness standards.

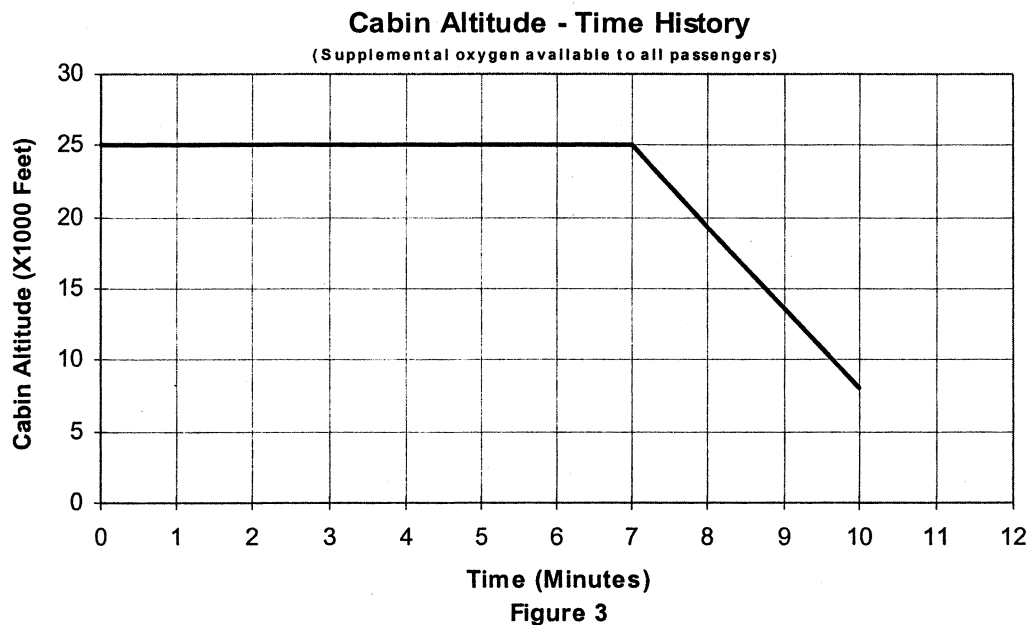
NOTE: For figure 3, time starts at the moment cabin altitude exceeds 8,000 feet during depressurization. If depressurization analysis shows that the cabin altitude limit of this curve is exceeded, the following alternate limitations apply: After depressurization, the maximum cabin altitude exceedence is limited to 30,000 feet. The maximum time the cabin altitude may exceed 25,000 feet is 2 minutes; time starting when the cabin altitude exceeds 25,000 feet and ending when it returns to 25,000 feet.

1. For the purposes of this special condition, the pressurization system includes bleed air, air conditioning, and pressure control systems. The pressurization system must prevent the cabin altitude from exceeding the cabin altitude-time history shown in Figure 3 after each of the following:

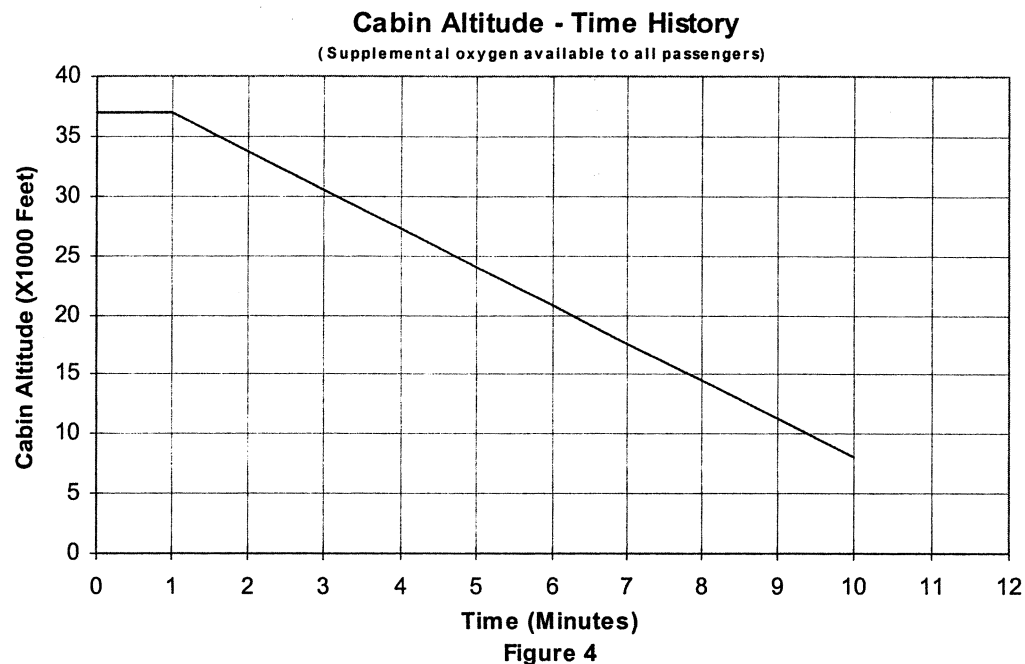
NOTE: For figure 4, time starts at the moment cabin altitude exceeds 8,000 feet during depressurization. If depressurization analysis shows that the cabin altitude limit of this curve is exceeded, the following alternate limitations apply: After depressurization, the maximum cabin altitude exceedence is limited to 40,000 feet. The maximum time the cabin altitude may exceed 25,000 feet is 2 minutes; time starting when the cabin altitude exceeds 25,000 feet and ending when it returns to 25,000 feet.

2. The cabin altitude-time history may not exceed that shown in Figure 4 after each of the following:
