Service Bulletin (SB) No. CF6–80C2 S/B 78–1068, Revision 2, dated May 16, 2005, any earlier revision, or original issue, or SB No. CF6–80C2 S/B 78–1077, Revision 1, dated May 16, 2005, or original issue; and

#### Modifying the Latching System of the Fan Reverser

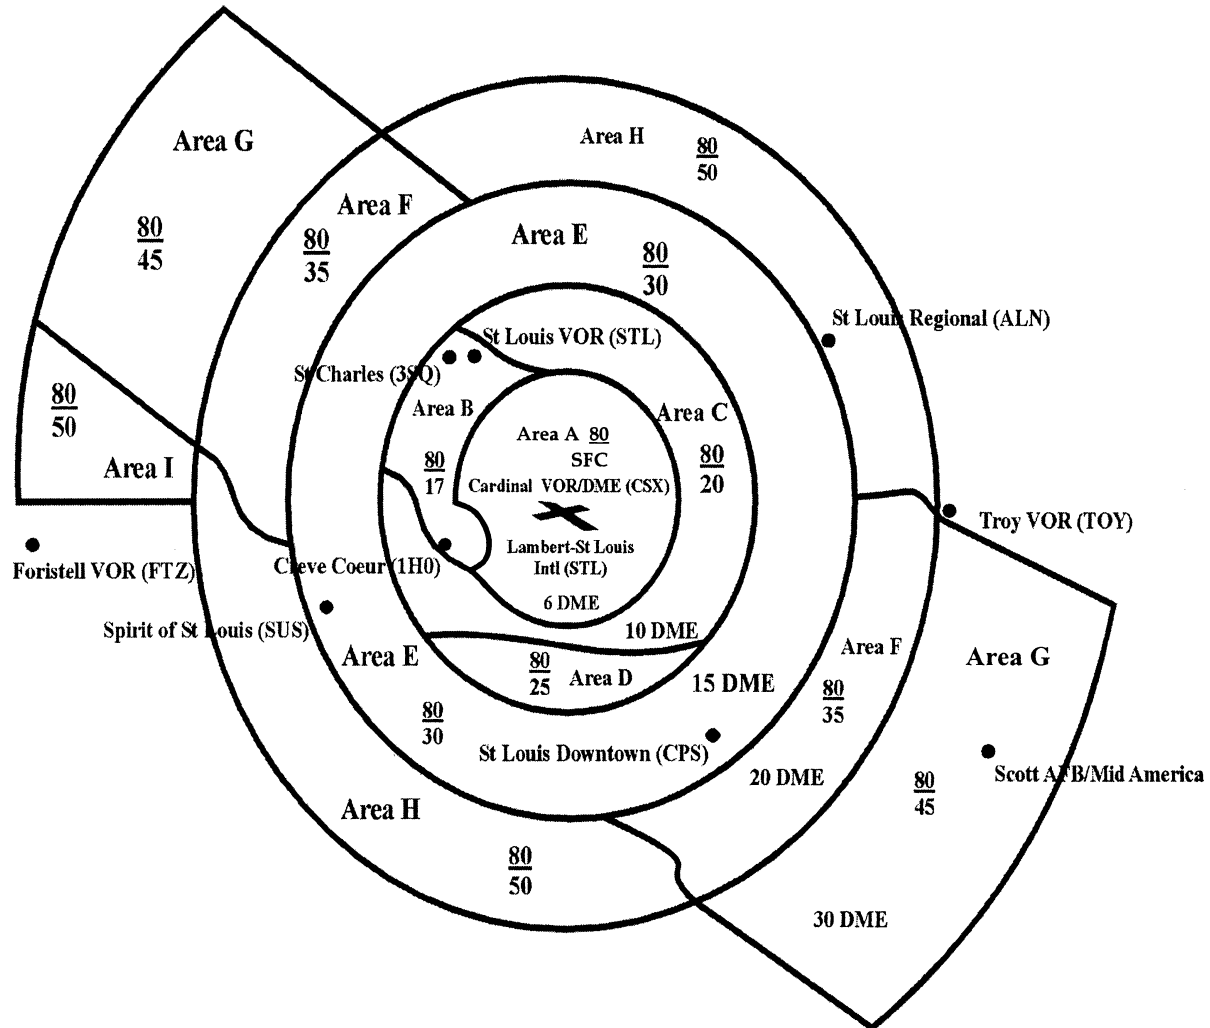
# ST. LOUIS, MO CLASS B AIRSPACE AREA

including 8,000 feet MSL (80/SFC). Also, the 1.5 NM radius exclusion around Creve Coeur Airport was not depicted. This action replaces the graphic reflecting the correct altitudes for area A and the exclusion around the Creve Coeur Airport.
